Sticky Rock is unstuck

by AJ Weller Corporation, USA

The double-edge problem of sticking and abrasion at Florida Rock has apparently been solved by AJ Weller Corporation who recently redesigned the Polysius raw mill and improved material flow. A second project at the Newberry plant involved increasing wear resistance in the clinker dedusting system.

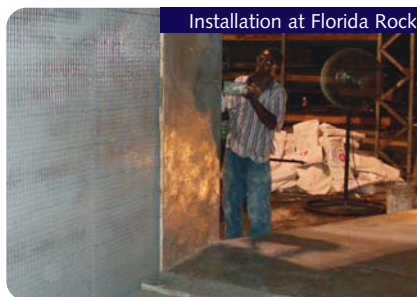
Installation at Florida Rock

The original duct wore out after three years of production. AJ Weller was asked to provide a turnkey solution that would eliminate the wear problem and continue to operate within the system's requirements. Working in conjunction with the team at Florida Rock, AJ Weller designed, fabricated and delivered a new elbow lined with WellerDensit™.

Florida Rock's previous experience with WellerDensit allowed it to make an informed decision much easier. AJ Weller supplied the elbow in two pieces for easy field installation. The Florida Rock management team commented that the workmanship of the fabrication provided a superior fit to the existing system and no installation modifications were necessary. Thus far, Florida Rock's expectations have been fulfilled and the elbow is now performing correctly during production.

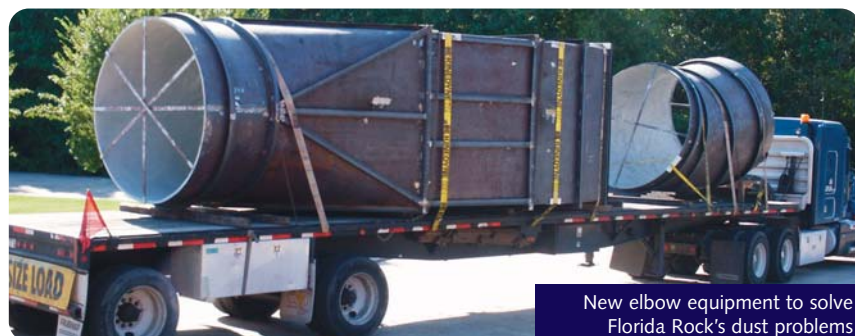
New elbow equipment to solve Florida Rock's dust problems

The WellerDensit technology is advantageous for a number of reasons: the wear liner makes use of a mechanical bond in the form of an expanded metal mesh, that is welded onto the inner steel surface to be protected, offering many advantages. The difference in thermal expansion between steel and the ceramic composite material becomes absorbed, so broad cracks and the risk of spalling are avoided.
