Tackling Restricted Flow and Abrasion

Ken Ryan, A.J. Weller Corp., USA, looks at the double edge problem of sticking and abrasion.

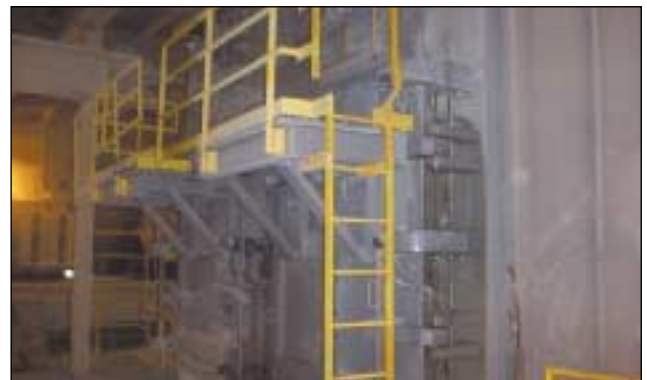
Dorol-RMR41-20-315 roller mill.

The plant uses a Polysius system that includes a single vertical roller mill with a rated capacity of 192 tph. The table's diameter is 135 in. dia with 75 in. rollers operating at 26.7 rpm, 1750 Hp. The mill can easily provide more than enough raw material feed to operate the kiln at maximum efficiency.

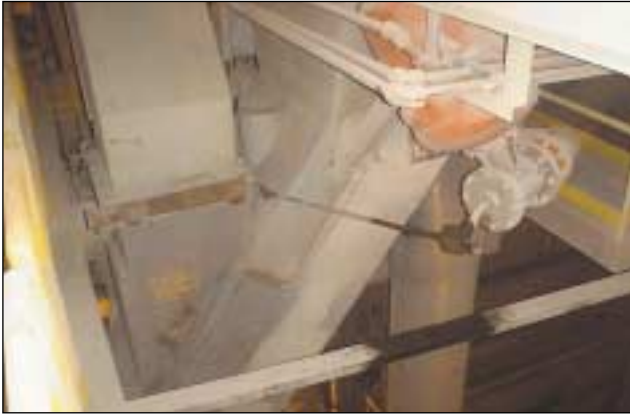
The raw feed entering the mill was measured at -4 in. When flow was not restricted, the impact point on the chute was facing two kinds of wear problems, heavy impact from the size of the material, and severe abrasion from the silica content. The straight sided chute with 90° angles allowed material to pack and bridge.

Raw feed inlet chute.

Preparations were made to install WellerCLAD HYPOL™ during Spring 2001. The liner system was supplied cut to fit and arrived ready to be installed. The maintenance team welded each liner in place and used narrow strips in the corners of the chute to open the angles. The steel backing on the material made for quick and easy installation with standard welding equipment and rods. Installation was completed without any problems and the mill was brought back on line with the rest of the plant.
