## Essroc's raw feed production increased with new liner system

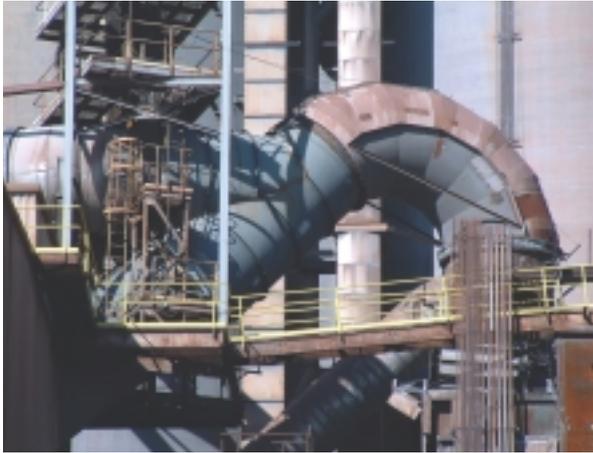
Upon closer examination of the production process, the plant engineering staff determined that a critical 48-degree elbow between the raw mill and the electrostatic precipitator was causing the diminished airflows. This 8-ft-diam elbow not only carried limestone dust but also had a second source of kiln dust that was introduced into the air

stream. This combination of highly abrasive fines and elevated temperatures riddled the elbow with holes. Plant maintenance regularly patched the elbow with abrasion resistant steel plates and ceramic wearing compounds, spending roughly 140 work-hours per year on the problem.

This 8-ft-diam, 48-degree elbow between the raw mill and the electrostatic precipitator was causing diminished airflows.

During the 1998 spring shutdown, the raw mill elbow was lined with Weller Wear Flex 2000, a process that took place over seven days. A.J. Weller provided a technician to oversee the installation and train a local refractory company hired by Essroc. Internal staging was used to aid in the installation. Prior to installation, the existing liner system, a combination of a ceramic and a wear resistant compound, was removed. Then the components of the anchoring system were welded into place. It was determined that minimal metal work was needed because WellerDensit added structural strength to the substrate. A 1 1/4-in.-thick liner was deemed appropriate for the job and was installed.

The Nazareth Plant I is in the process of modifying its dust collection system. During the 2003 shutdown, the raw mill elbow was lowered to the ground to allow for a modification in the ductwork leading into the precipitator. This gave plant personnel an opportunity to inspect the raw mill elbow and make any necessary repairs before being lifted into place. A minimal amount of repairs were needed to restore the elbow back to its original WellerDensit liner condition. This was accomplished by using a small amount of material and completed within an eight-hour window using a local mechanical maintenance contractor.

The plant engineer added, “After five years, the WellerDensit held up so well rarely did we have any leaks or holes in the elbow, and it looked like at least 75% of the WellerDensit was still intact. I’m expecting to get at least another five years before any liner replacement is necessary. I have started to install the liner on other areas of the duct where wear holes appear.”
