Improving Elbow Designs

Randy Dillard and Ken Nichols, A. J. Weller Corp., USA, report on the solution to a mitered elbow wear problem, which was recently implemented for North Texas Cement.

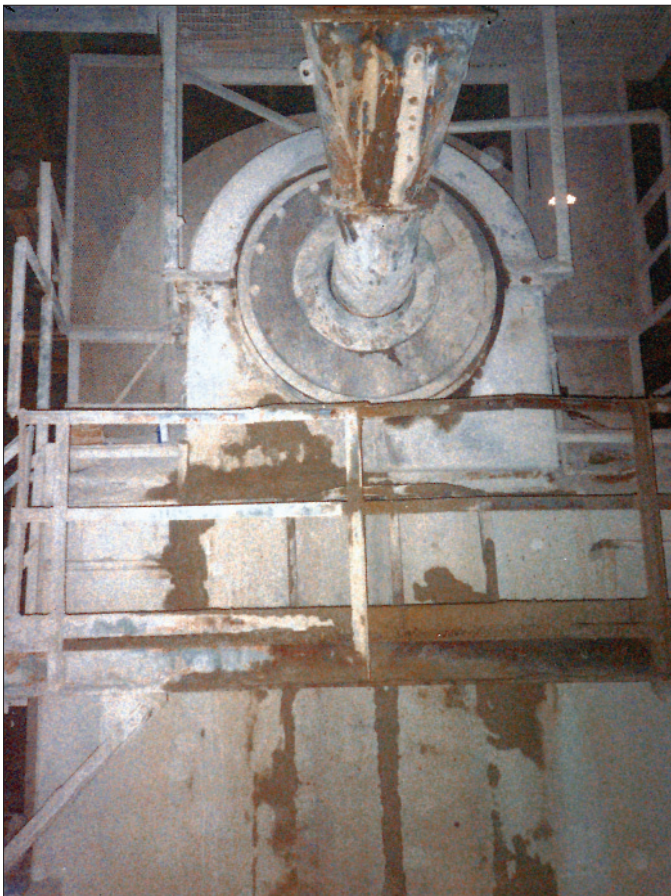
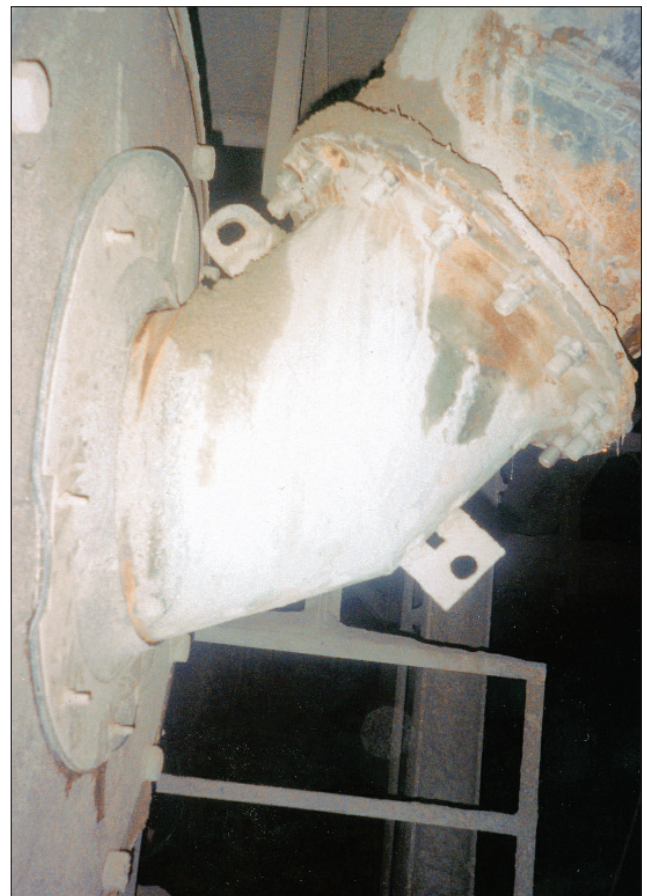
North Texas Cement had been experiencing extreme wear in the back 18° of its mitered elbows transporting raw material into the ball mill grinding chambers. Due to the high maintenance cost and production interruptions that repair was expected to cost, the company asked the A. J. Weller Corp. to find a cost effective solution.

Left and right. The North Texas Cement inlet elbow transporting raw feed to the ball mill.
